COMPOSITE REPAIR OF LARGE FUSELAGE FRAME STRUCTURE

2001 Designee Conference

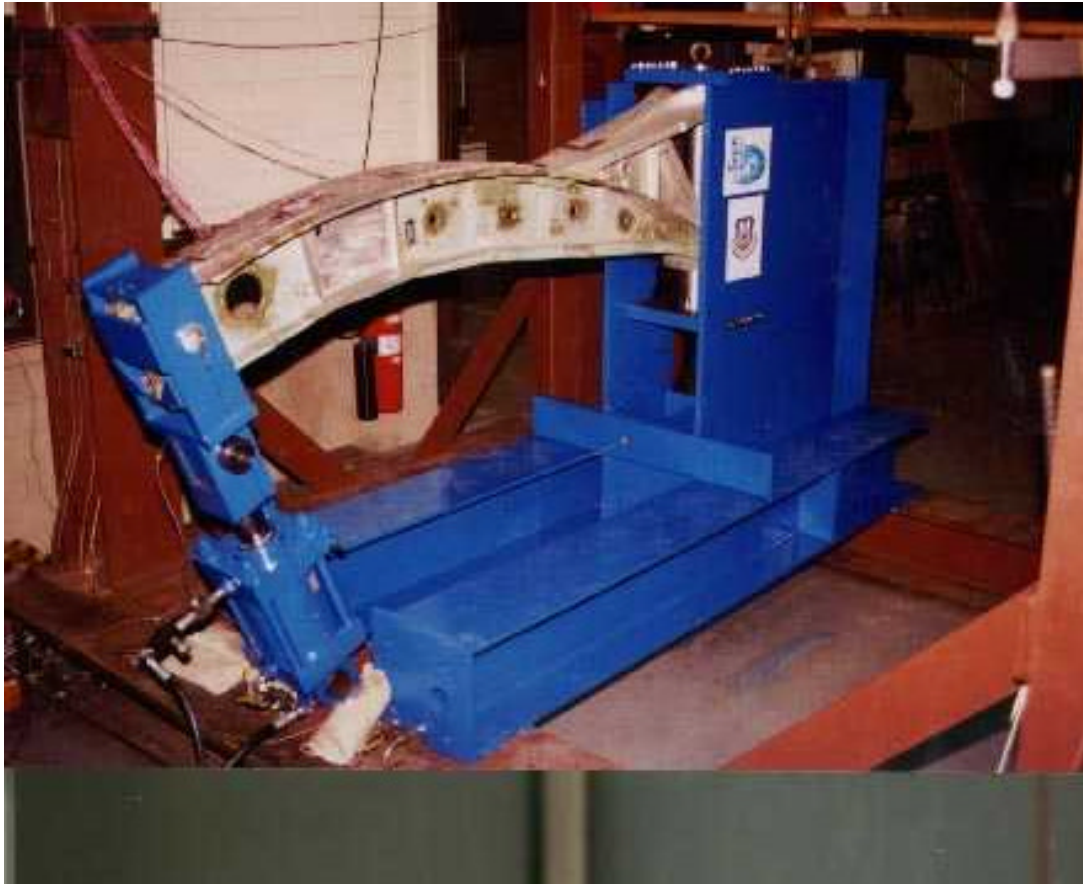
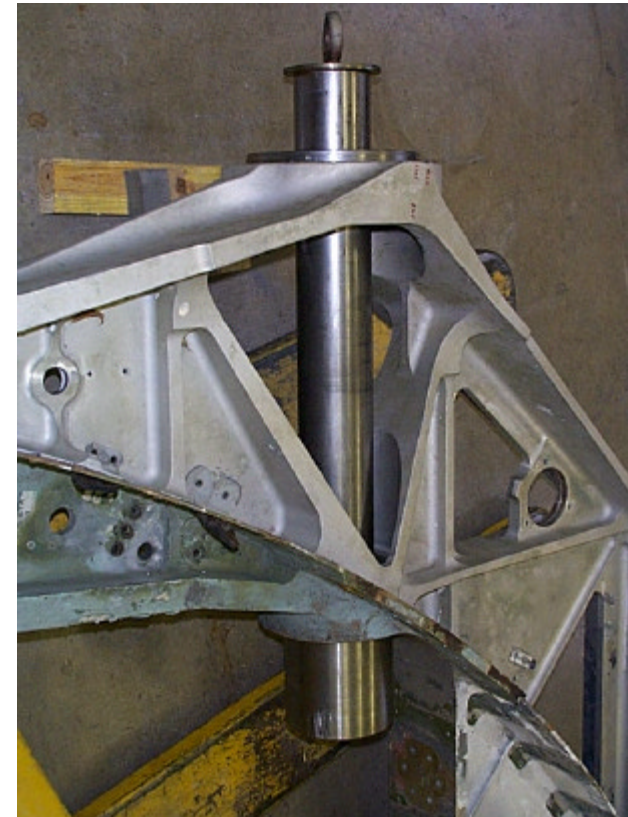
Test Setup

- Devise a repair scenario that created a growing crack that is a function of a complicated stress field in a region of a large forging that would be difficult to repair.
- Fabricate a test rig that could inexpensively create this complicated stress field in surplus 998 Frames from the C-141

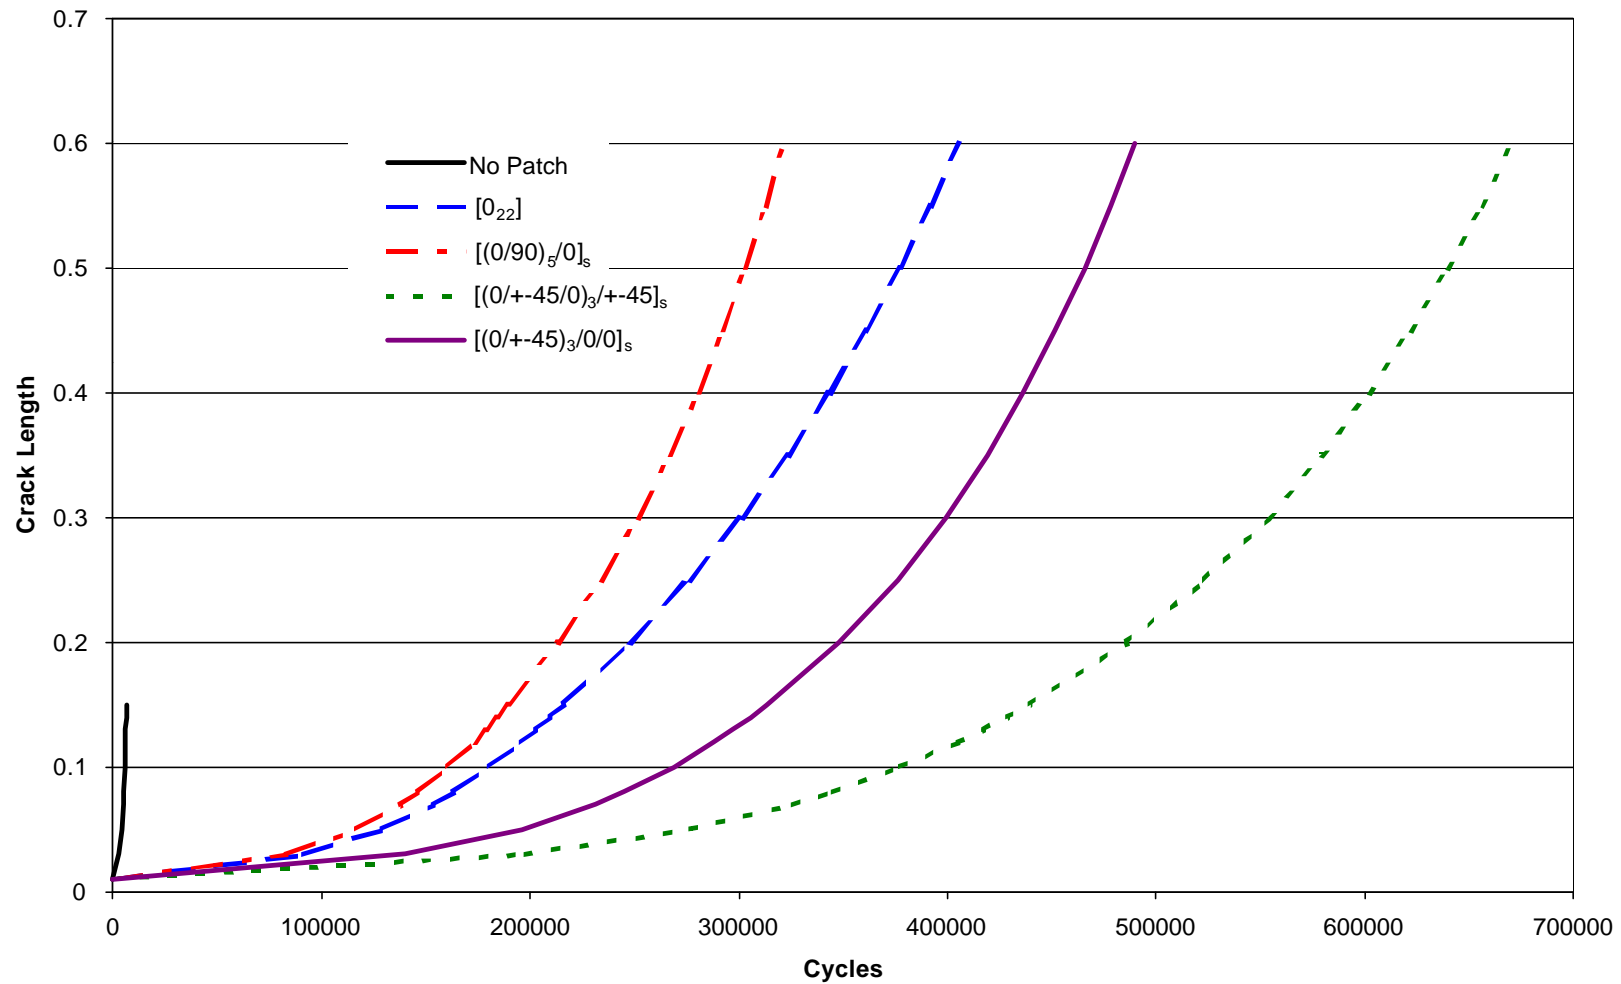
Doubler Comparisons

**Crack Growth Analysis Comparison
20 kip Constant Amplitude**

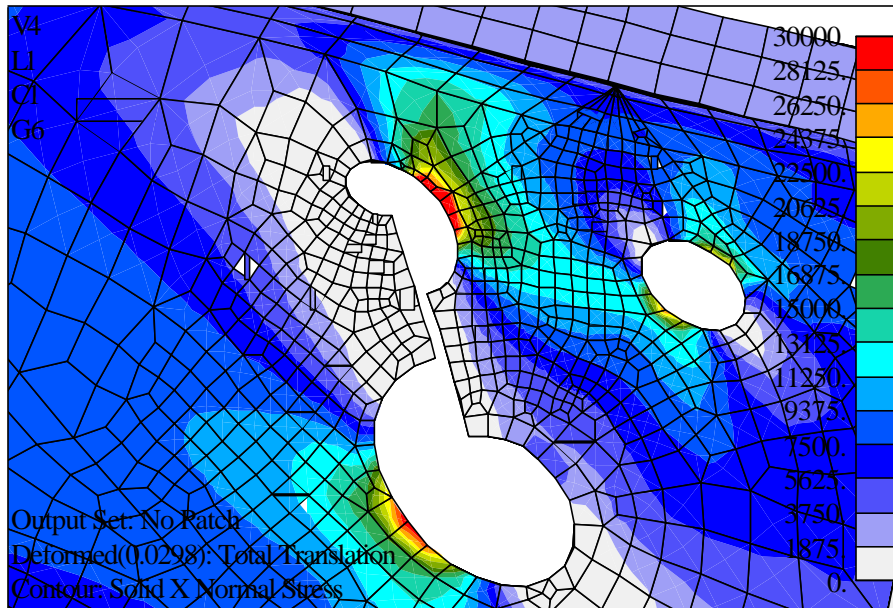
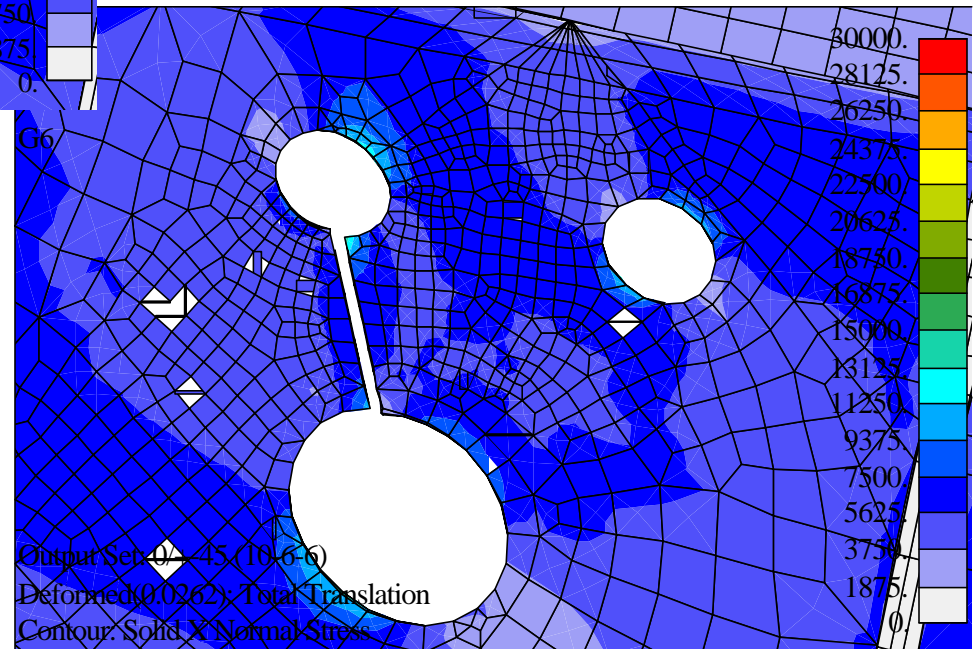
FEM Of Repaired Test Area

Unrepaired

Repaired

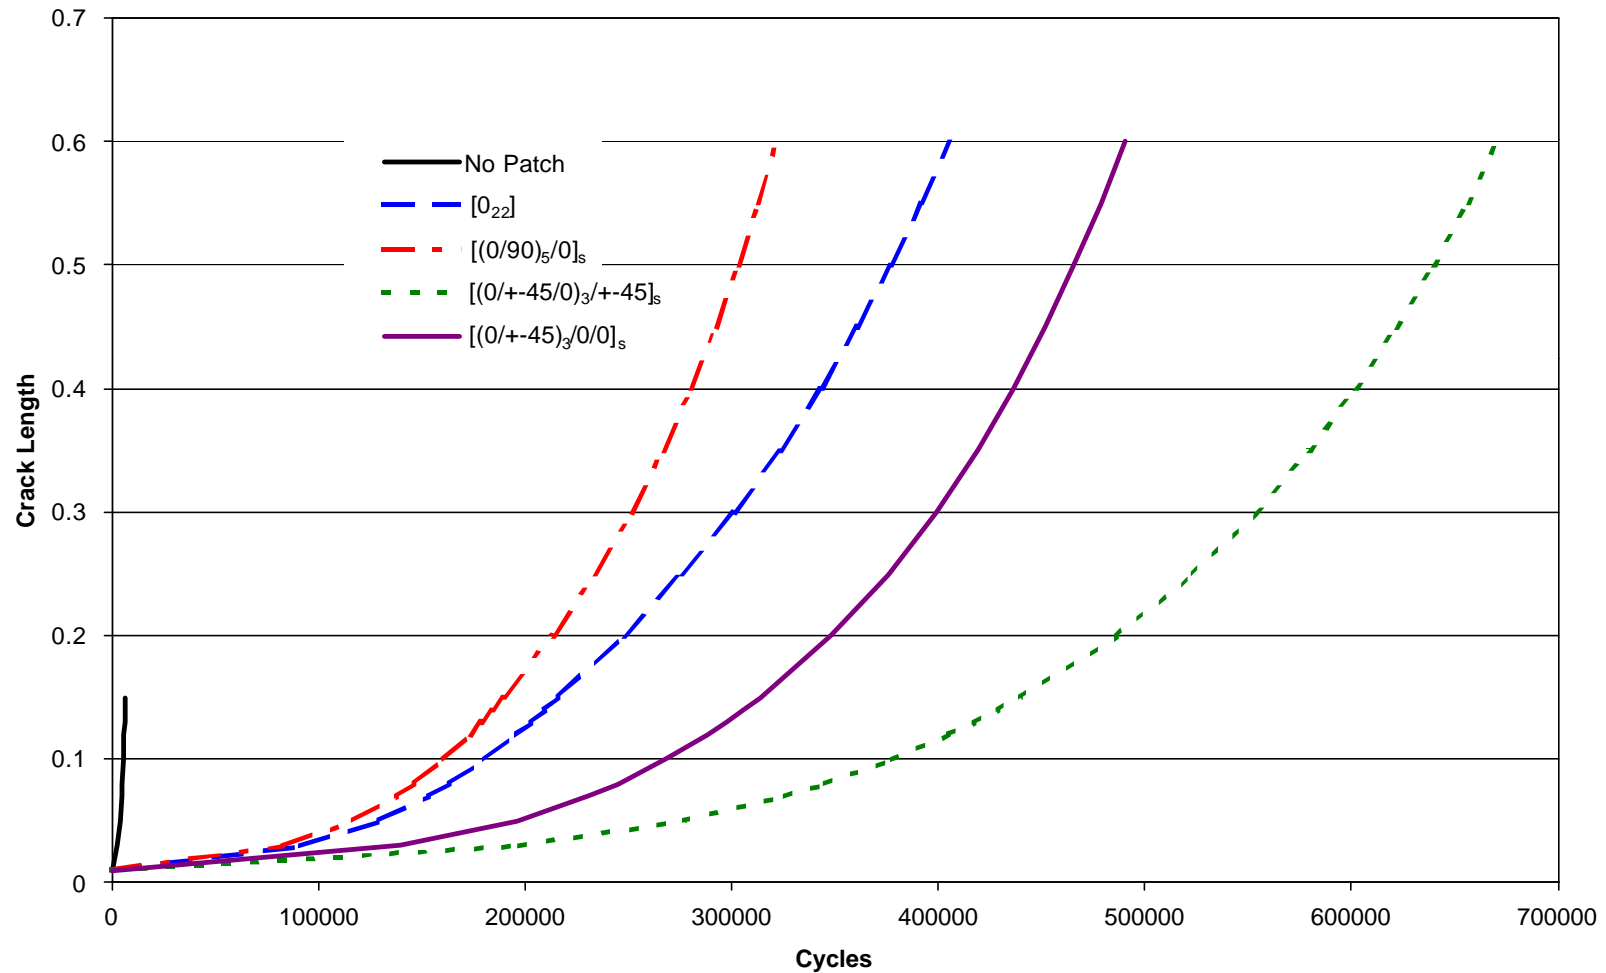
FEM Of Repaired Test Area

**Crack Growth Analysis Comparison
20 kip Constant Amplitude**

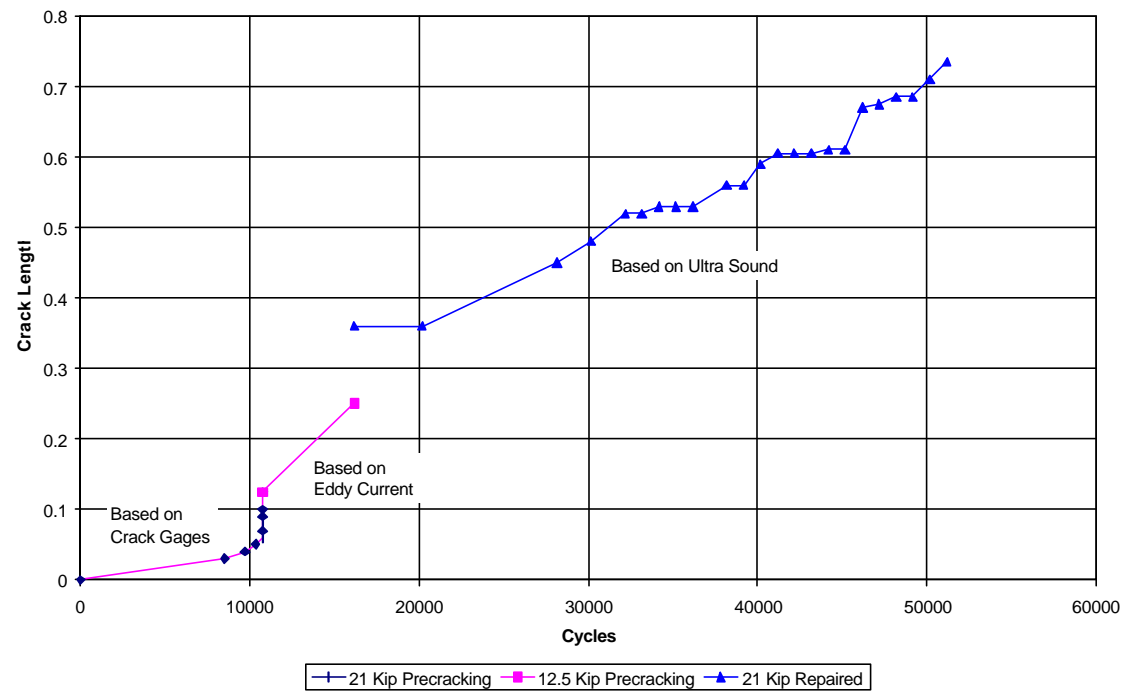
Crack Growth

Test 2 Cycles vs. NDI Measured Crack Length
